Non-Destructive Evaluation of Circumferential Welds in Wind Turbine Tower Shells Using Magnetic Particle Testing

Hery Tri Waloyo^{1*}, Saeful Bahri²

^{1,2}Mechanical Engineering, Sultan Ageng Tirtayasa University, Cilegon, Indonesia

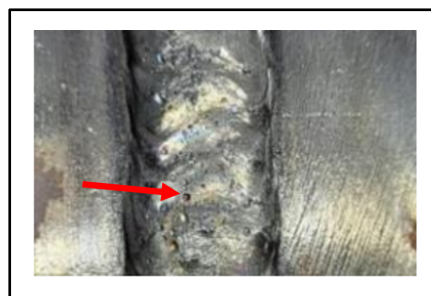
Figure 2. Surface cluster porosity

Figure 2 shows a porosity defect located on the weld surface. This defect is characterized by the presence of small clustered cavities formed due to trapped gas during the solidification of the molten metal. Such defects commonly occur when gas is unable to escape from the weld pool during the welding process.

The presence of porosity defects, as observed in Figure 2, is generally associated with gas entrapment during the solidification of molten metal. This condition may occur due to contamination, improper shielding gas protection, or excessive moisture in the electrode or base material. Meanwhile, slag inclusion defects indicate that non-metallic slag was trapped in the weld metal, which may result from insufficient cleaning between welding passes or improper welding techniques.

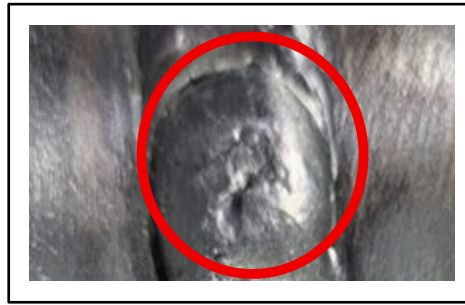
Figure 3. Slag inclusion

Figure 3 presents a slag inclusion defect, which occurs when non-metallic slag becomes trapped within the molten weld metal. After the cleaning process, the defect appears as small cavities or irregular openings on the weld surface.

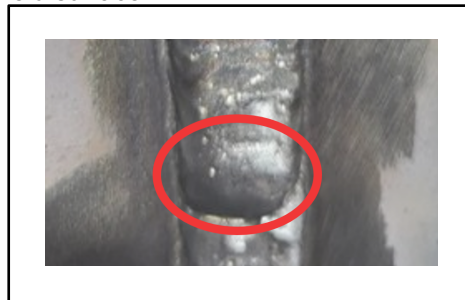
Figure 4. Overlap

Figure 4 illustrates an overlap defect, which is identified by the accumulation of weld metal that flows onto the base metal without proper fusion. This defect generally occurs due to improper welding parameters, such as excessive welding speed, low heat input, or improper electrode manipulation.

The overlap defect observed in the inspection suggests that the weld metal flowed onto the base metal without achieving proper fusion. This condition is commonly related to improper welding parameters, such as excessive welding speed, low heat input, or incorrect electrode angle during the welding process. In addition, the identification of linear indications and rounded indications during the inspection suggests the presence of subsurface cracks and voids, which may originate from thermal stresses, rapid cooling, or internal material discontinuities.

The presence of these defects indicates that the welding process parameters and operational control play an important role in determining the final weld quality. Therefore, proper parameter selection and welding technique are essential to minimize the occurrence of discontinuities in welded structures.

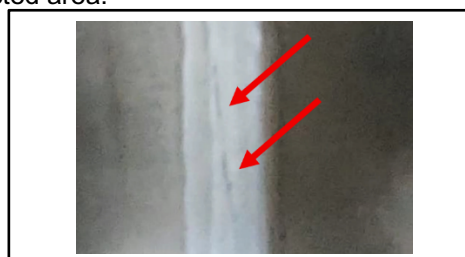
Meanwhile, other observations indicate the presence of subsurface defects, which are identified by the accumulation of magnetic particles on the inspected surface. The accumulation of particles forming a linear indication suggests the presence of a subsurface crack, as shown in Figure 5. In addition, black spot indications observed during the inspection represent the presence of **voids** beneath the surface, as shown in Figure 6. These indications appear due to magnetic flux leakage caused by discontinuities within the material, allowing the magnetic particles to accumulate and form visible patterns on the inspected area.

Figure 5. Crack

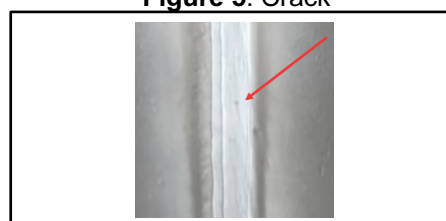
Figure 6. porosity
